JRC TECHNICAL REPORTS

Quarterly report on NPP events

July – September 2018

JRC113805

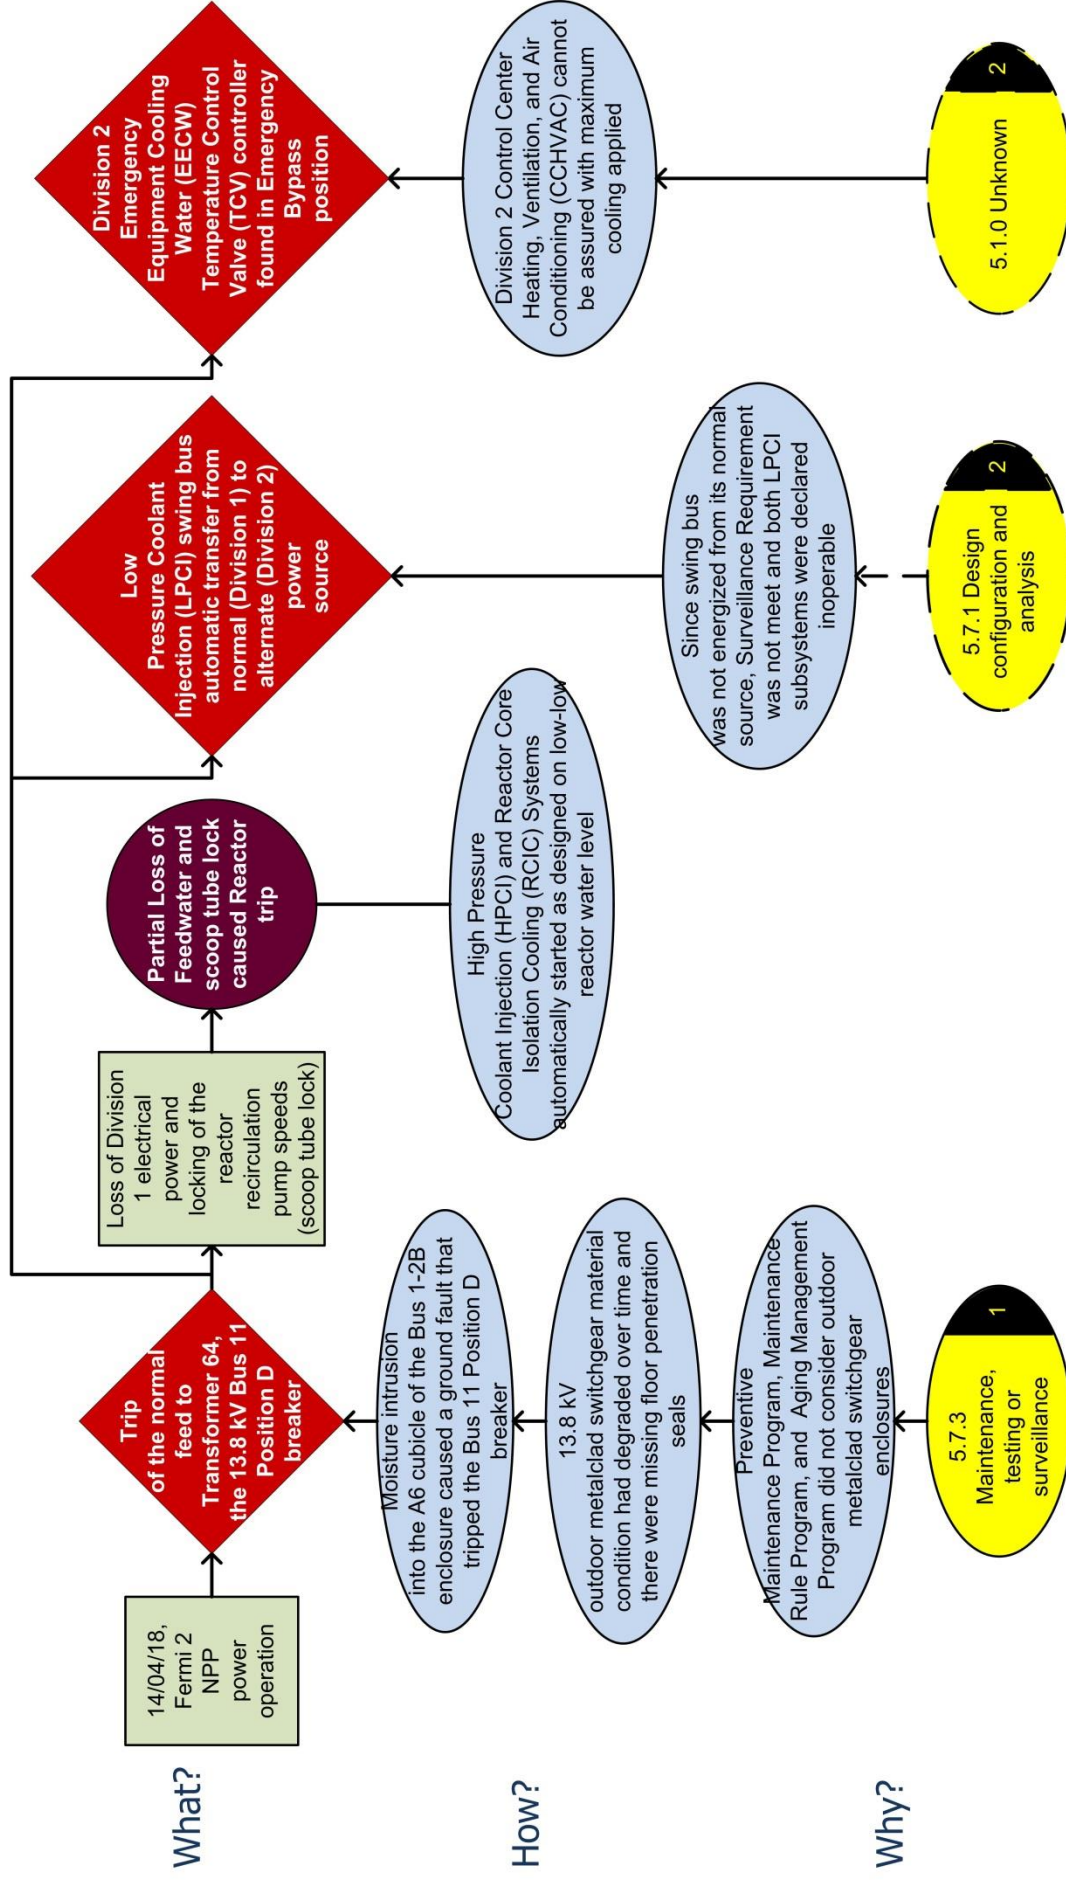
Loss of Division 1 Offsite Power Causes Partial Loss of Feedwater Leading to ECCS Injection and Reactor Scram

The partial loss of feedwater and scoop tube lock were caused by a loss of Division 1 electrical power which occurred following a trip of the normal feed to Transformer 64, a 13.8 kV breaker. Division 1 emergency diesel generators automatically started and energized Division 1 buses.

Investigation has determined the direct cause of this event to be moisture intrusion into one cubicle of the bus enclosure, which caused a ground fault that tripped the breaker. The root cause evaluation determined that the organization failed to recognize the degradation of the bus enclosure as a failure mechanism of the switchgear.

Immediate corrective actions were completed to eliminate moisture intrusion into the bus enclosure. Corrective actions to prevent recurrence include developing and implementing a preventive maintenance strategy for outdoor metal clad switchgear.
