JRC TECHNICAL REPORTS

Quarterly report on NPP events

January – March 2019

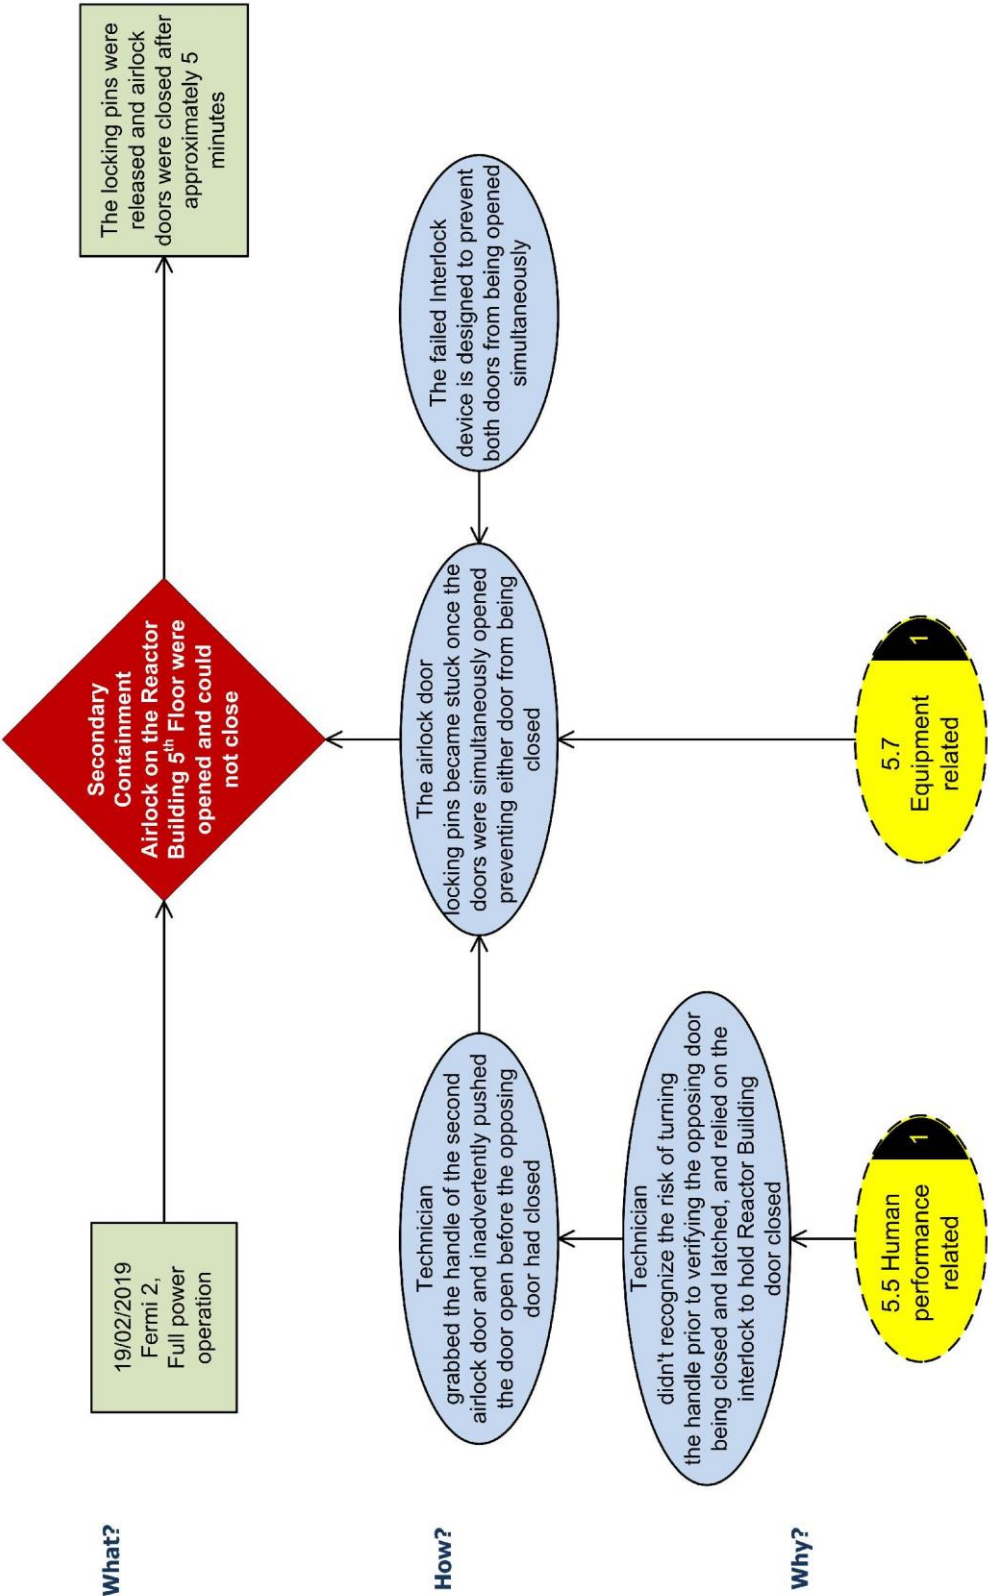
Secondary Containment Airlock Doors Opened at the Same Time Resulting in a Condition Prohibited by Technical Specifications

With the reactor at full power, plant personnel notified the Main Control Room that both doors in the Secondary Containment airlock on the Reactor Building were opened and could not close. The airlock doors were opened simultaneously for a period of approximately five minutes.

A technician had opened both air lock doors simultaneously when he egressed through first door and grabbed the handle of the second airlock door and inadvertently pushed the door open before the opposing door had closed. The interlock device for the doors had failed. The interlock is designed to prevent both doors from being opened simultaneously. The maximum Secondary Containment (SC) pressure observed during that time remained within limits.

The Clearinghouse staff has noted that events similar to this one are reported often (71 reports concerning airlocks have been recorded on the Clearinghouse database in the last five years, with one plant reporting five incidents during one single outage). While the duration of the period when both doors are open simultaneously is typically very short and therefore the safety significance of the individual occurrences is negligible, the high

number of events reported points at a certain «normalization of deviance» phenomenon, deserving due attention.

Besides troubleshooting, improved surveillance tests, procedure revisions and training, usual corrective actions include:

- Install signs instructing personnel how to access or leave the airlock.*
- Introduce a time delay, which allows additional time for the interlock mechanism to actuate and prevent the other door from being opened.*
- Review of airlock door operating practices.*
- Assign designated door operators.*
- Establish backup door indication verification technique prior to re-commencing reactor building entries.*
- Redesign the airlock components (like the latching mechanism) to avoid manual actions by airlock's' users.*
- Coach the individuals involved with respect to the use of airlock doors.*
