## JRC TECHNICAL REPORTS

# Quarterly report on NPP events

*April – June 2019*

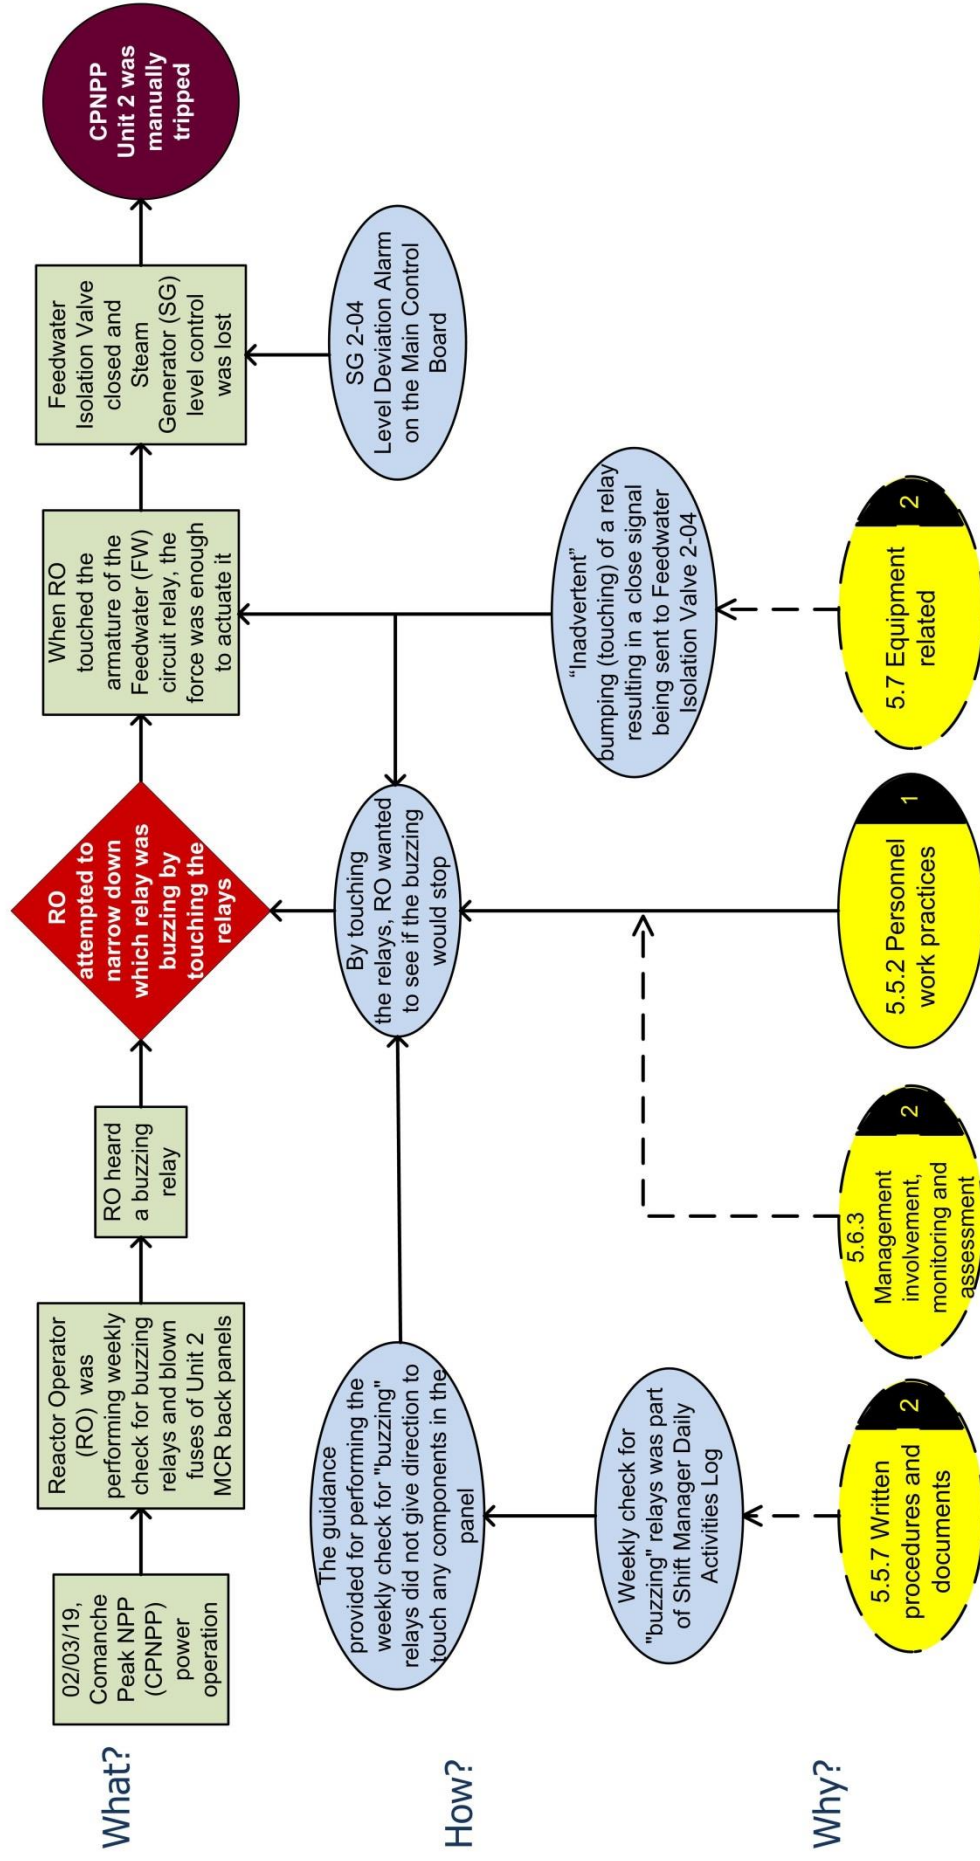
# Manual Reactor Trip Due To Feedwater Isolation Valve Closure

A Reactor Operator (Utility, Licensed) was performing a weekly activity to check for buzzing relays and blown fuses in the Unit 2 Main Control Room back panels. During this activity, the Reactor Operator heard a buzzing relay and attempted to narrow down which relay was buzzing by lightly touching the relays to see if the buzzing would stop. When he touched the armature of the feedwater circuit relay, the force was enough to actuate it causing a feedwater isolation valve to close. At 0317, Unit 2 was manually tripped due to this unexpected valve closure and loss of Steam Generator level control. All systems functioned as designed and the Auxiliary Feedwater Pumps started as designed due to low level in Steam Generator. There was no impact on Unit 1.

The cause of this event was the inadvertent bumping (touching) of a relay resulting in a close signal being sent to the feedwater isolation valve. The guidance provided for performing the weekly check for "buzzing" relays did not give direction to touch any components in the panel, and this was a human performance error by the Reactor Operator.

The Reactor Operator involved in this event was coached, and a site stand down was conducted on the event. Activities involving relay checks were temporarily suspended, and the weekly check for "buzzing" relays was removed from the Shift Manager Daily Activities Log. An evaluation of Operations, Control Room, and Field activities that potentially could challenge nuclear risk will be performed and all plant personnel are evaluating departmental activities to determine if similar risk challenges exist that require further evaluation.
