JRC TECHNICAL REPORTS

Quarterly report on NPP events

October – December 2019

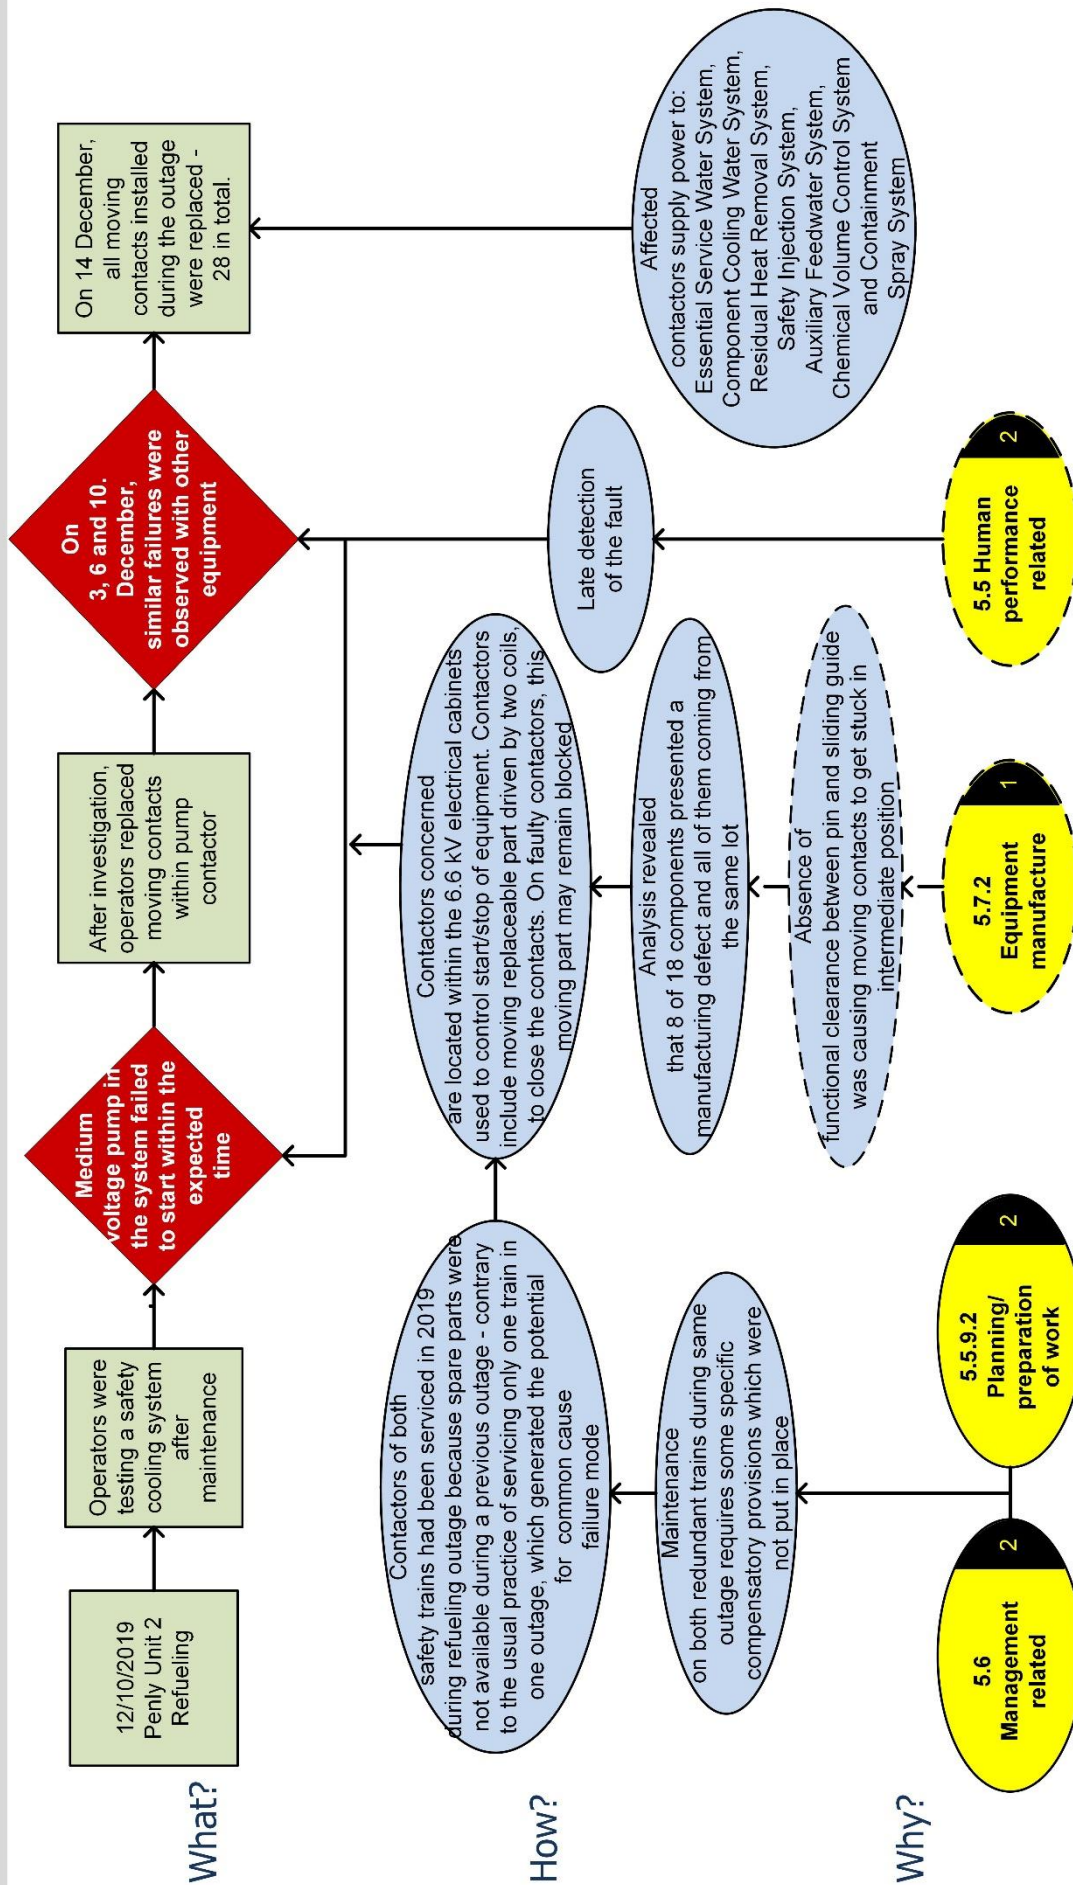
Defective Electrical Components

A contactor includes a moving replaceable part, driven by two coils, to close the contacts and to ensure that contacts remain closed. On the faulty contactors, this moving part may remain blocked in open position.

The preliminary cause of the problem identified by the contactor's manufacturer, after analysis, is the absence of a functional clearance between the pin and the sliding guide, potentially causing the moving contacts to get stuck in an intermediate position.

The operator has replaced 28 moving contacts in total. The analysis of the first 18 among them has revealed that 8 components presented a manufacturing defect, all of them coming from the same lot. In parallel, the operator is verifying if these faulty components could have affected other reactors in France.

On 14 December, as a precaution, all moving contacts installed during the outage were replaced.

The licensee replaced all faulty contactors before restarting the reactor, and is investigating the potential impact on other nuclear plants.
