JRC TECHNICAL REPORTS

Quarterly report on NPP events

January – March 2020

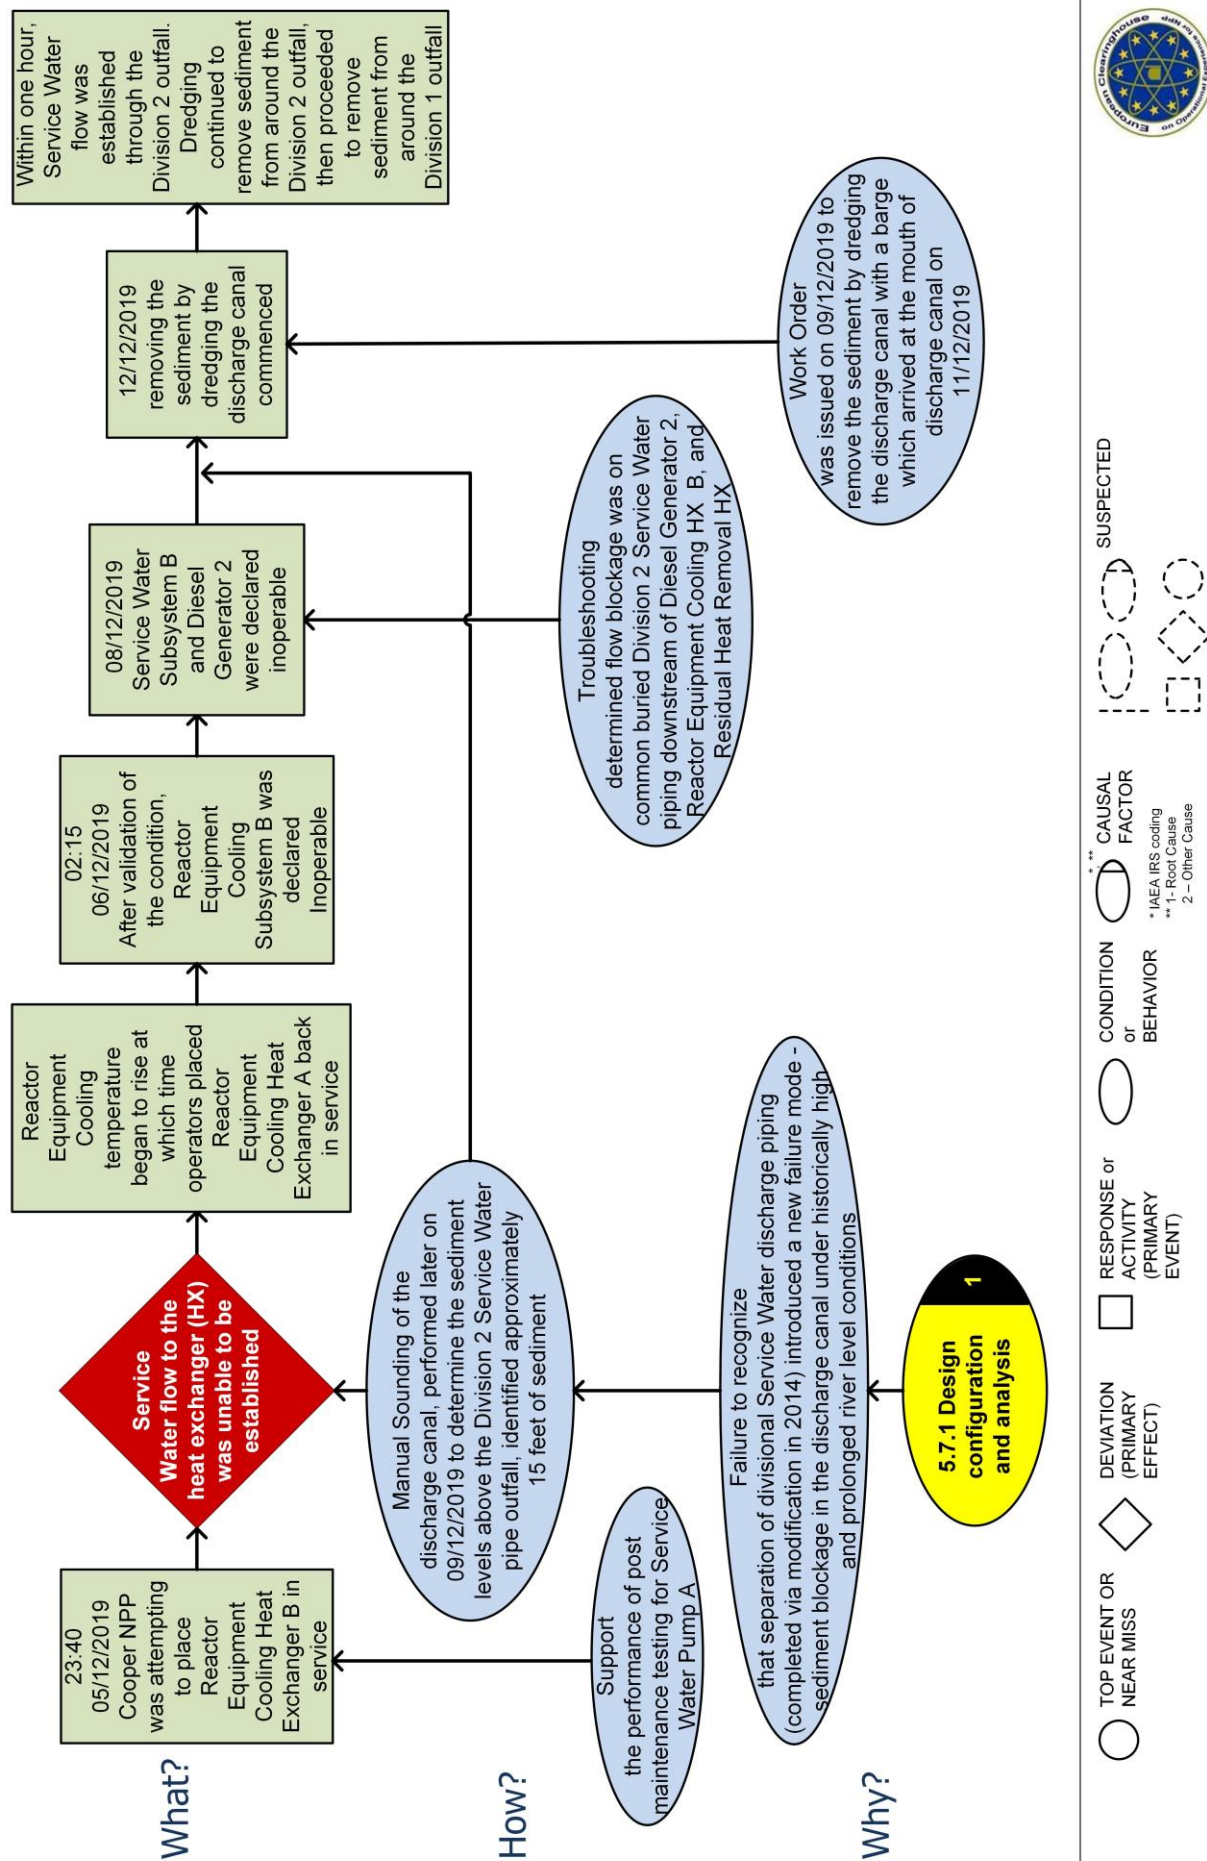
Division 2 Service Water Discharge Blockage Resulting in Unplanned Service Water Inoperability

While attempting to place Reactor Equipment Cooling Heat Exchanger B in service, plant staff was unable to establish the Service Water flow to the heat exchanger, which was then declared inoperable.

A few days later, troubleshooting located a flow blockage on the common buried Division 2 service water piping downstream of diesel generator 2, Reactor Equipment Cooling Heat Exchanger B, and Residual Heat Removal Heat Exchanger B. Manual sounding of the discharge canal was performed, and it determined that the sediment level above the pipe outfall was approximately 15 feet. Channel dredging with the aid of a barge and a pump was required to remove the sediment, and the service water was fully restored approximately one week after the beginning of the event. A temporary configuration change was in place during this time to mitigate the risk.

A modification to separate the divisional Service Water discharge piping carried out in 2014 had inadvertently introduced a new failure mode: sediment blockage in the discharge canal under historically high and prolonged river level conditions. This new failure mode was not recognised at the time the design change was prepared and implemented.
